SCALING OF CAVITATION DAMAGE

Stinebring, D. R.

Technical Memorandum
File No. TM 76-51
17 February 1977
Contract No. N00017-73-C-1418

The Pennsylvania State University
APPLIED RESEARCH LABORATORY
Post Office Box 30
State College, PA 16801

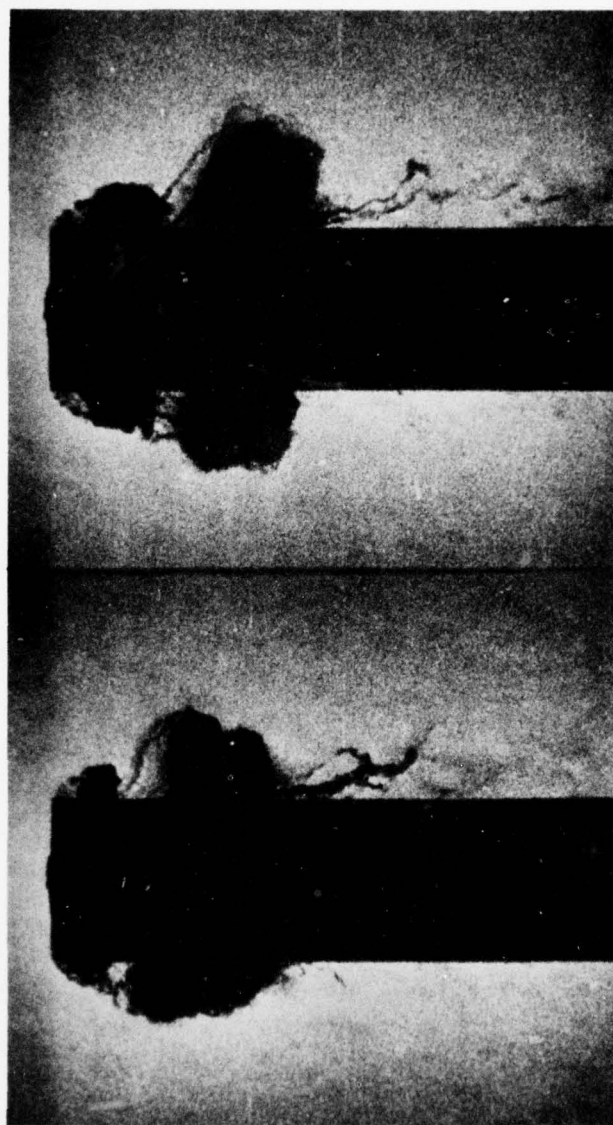
Figure 36 - High Speed Movie Segments Showing the Vortex Filaments Connecting the Sections of the Cavity After Breakoff (0.635 cm Diameter Zero-Caliber Ogive, $V_{\infty}=25$ m/sec, and $L/D=2.5$)

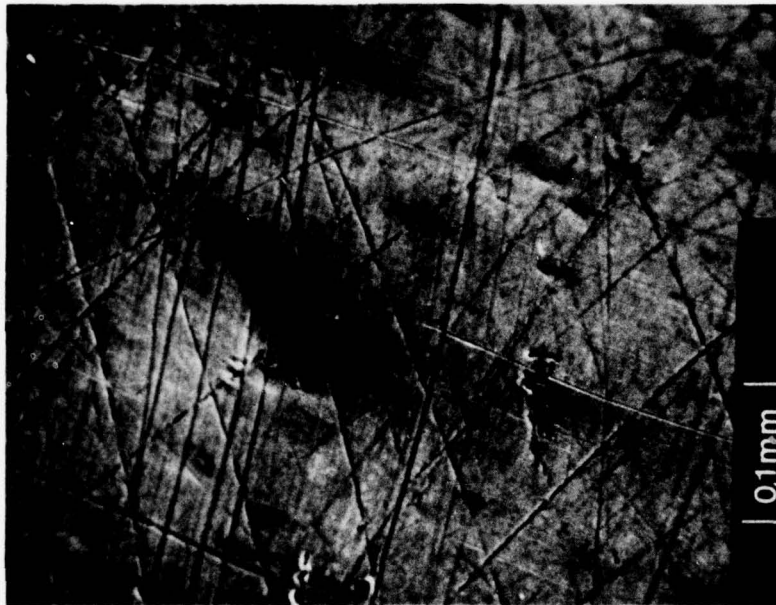
Figure 45 - SEM Micrograph of a Deep Indentation Caused by Cavitation and the Machine Tool Marks Showing No Material Removal from the Surface (Model 46, $V_{\infty}=50$ m/sec, $L/D=4$, Air Content - 8.5 ppm)

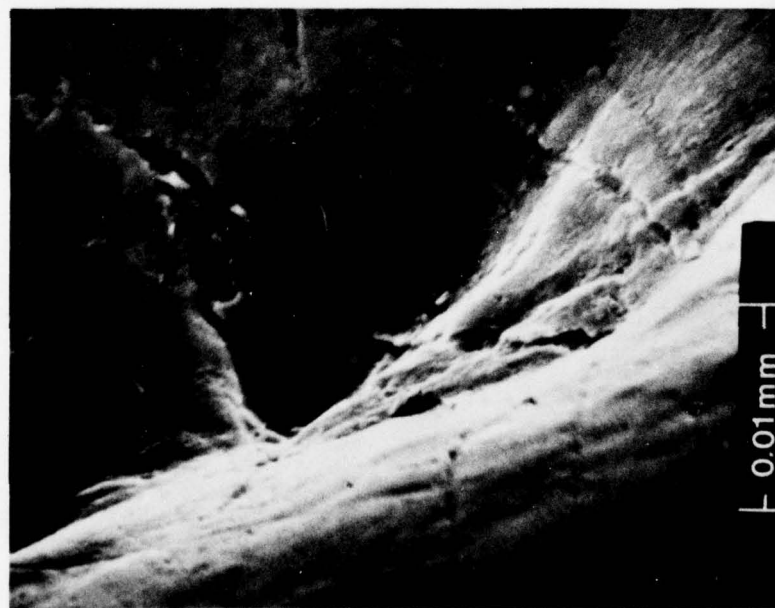
Figure 46 - SEM Micrographs of a Deep Cavitation Pit and Possible Strain Cracking at the Bottom of the Pit (Model 43, $V_{\infty}=43.4$ m/sec, $L/D=4$, Air Content - 9.84 ppm, and a 1.5-Minute Test Duration)

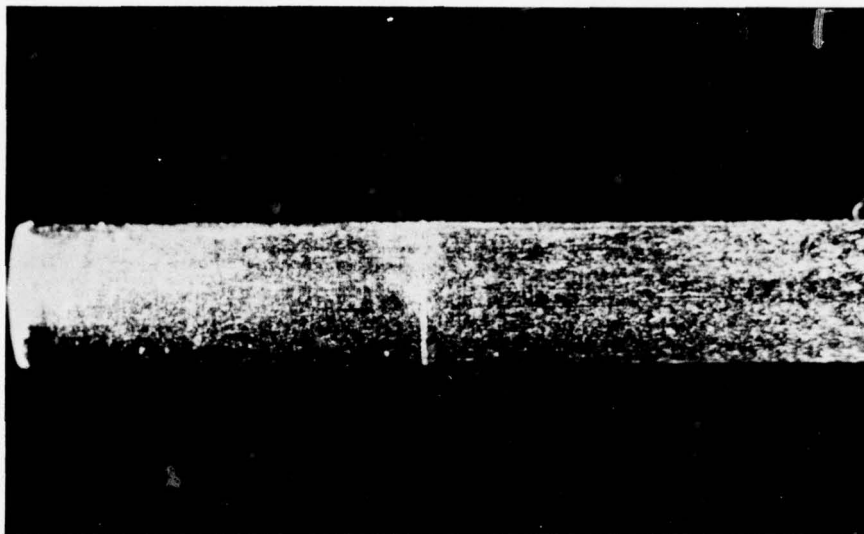
Figure 47 - Photograph of an Overall View of Spotting Corrosion of a Test Model (0.635 cm Diameter Zero-Caliber Ogive, Model 20, $V_{\infty}=23$ m/sec, $L/D=3$, Air Content - 20 ppm, and a 60-Minute Test Duration)
